# Revisión, observaciones y consideraciones sobre la erosión a alta temperatura en PS TBC para inspección técnica en turbinas a gas

## High temperature erosion observations, considerations and overview in PS YSZ TBC for power gas turbine technical inspection

Augusto César Barrios<sup>1</sup>, Gabriel Jaime Ovalle<sup>2</sup>, José David Acosta<sup>3</sup>,  
Andrés Felipe Sánchez<sup>4</sup>, David Alejandro Marulanda<sup>5</sup>,  
Óscar Alejandro Arroyave<sup>6</sup>, Freddy Jiménez Navas<sup>7</sup>, Carlos Mario Serna<sup>8</sup>

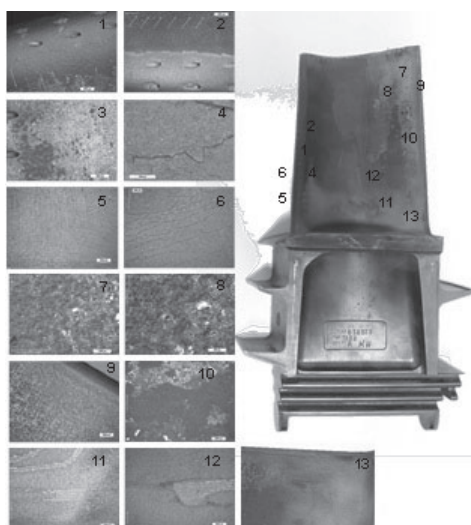
**Figure 6.** Liner dissection, several topographies were obtained by stereoscopy across the gas flow path.

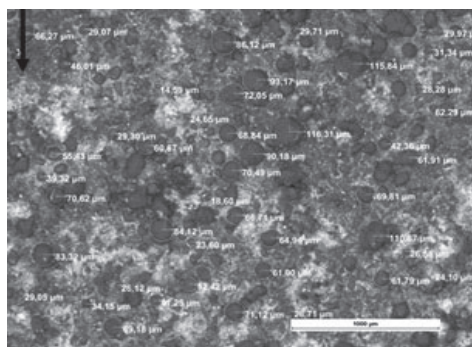
**Figure 7.** Measurements on eroded surface liner section 2D

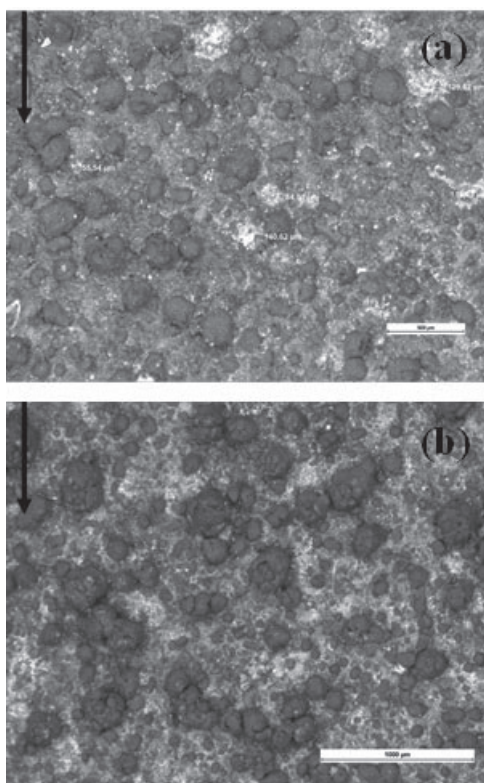
Typical morphology of liner TC that include splats, unmelted particles and contaminants; The quality of a TC is defined by the level of splat formed during process. Figure a) in the plasma deposition process unmelted particles can cohere to form a single and larger particle, figure 8 b), this could determine other degradation mechanisms. In figure 9 the transition from major (left) to minor (right) erosion was observed, the gas flow moves and impact in certain zones according to the combustor position and combustion conditions, the secondary air also has effects on the flow direction of gas. The splat removal is more intense on the left side of this micrograph; the formed valleys may increase the roughness and gas turbulence near the surface.

**Figure 8.** Stereoscopy micrograph of liner level 2 (a) detachment of unmelted particles and (b) their morphology. The black arrow indicates the average flow direction.

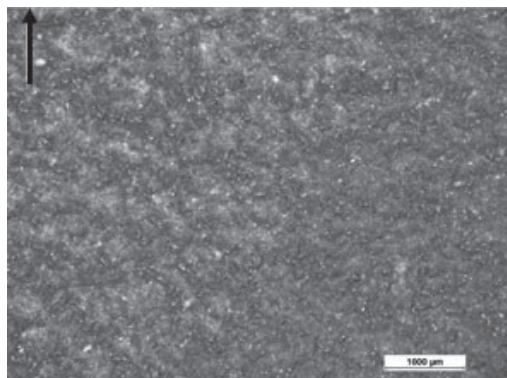
**Figure 9.** Stereoscopy micrograph of liner, section 3, center.

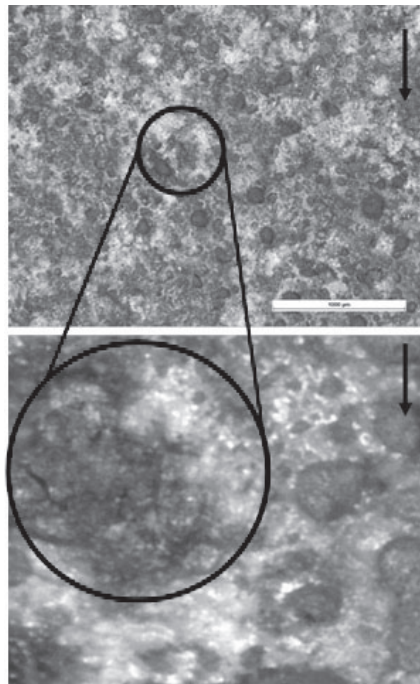
The great quantity of detached particles reveals a new TC surface again, the EDS test confirm that the new surface is TC and not BC. The size of the footprints may offer a perspective of the removed particles; the first removed ones are the larger particles. There is a tendency, the small unmelted particles have not yet been detached from the surface and the big ones leave a mark on the surface. These marks have a “halo pattern” due possibly to intersplat contact and noncontact area, Figure 10.

**Figure 10.** Stereo micrograph of tc of liner 2d, there is a wide particle removal across de surface; the imprint morphology indicates the intersplat or splat/particle contact area.

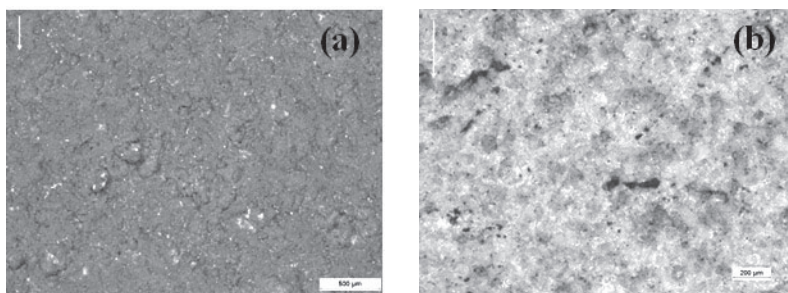
**Figure 11.** Two sections of the liner, far from the combustor, (a) the first micrograph has revealing ink and (b) the appearance of the tbc when deposited.

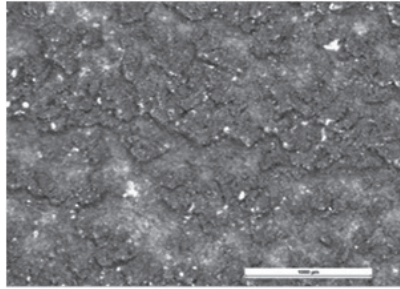
The zones where the splats are well deposited present a uniform pattern of wear with defined intersplat spaces and limits. The splat structures are degraded possibly because of high localized temperatures. By contrast, in figure b) there is a great quantity of unmelted particles in a wide size distribution. In the erosion process there are two possibilities: the particles appear after splat removal or the particles were removed first, the first event is not defined yet, but the micrograph b) may offer a tendency: the red ink on valleys means splats were not removed at first.

**Figure 12.** Well deposited splats, thermally degraded and some other were removed.

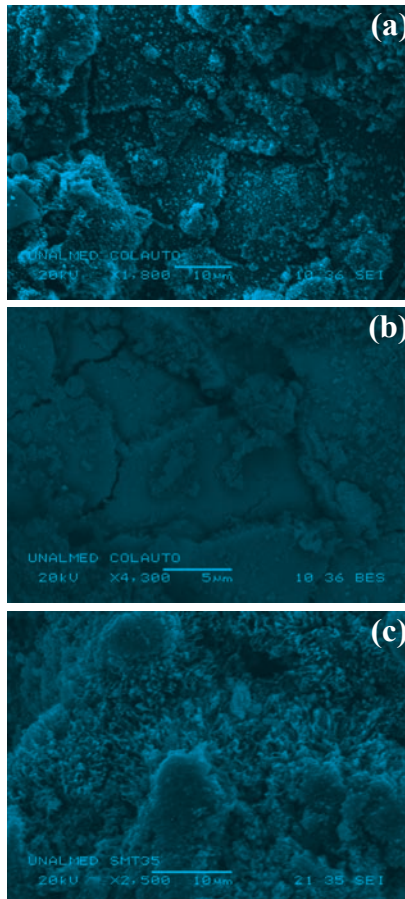
**Figure 13.** Three types of degradation: (a) (b) splats are removed by parts via intra splat cracks, (c) internal columnar structure revealed by erosion

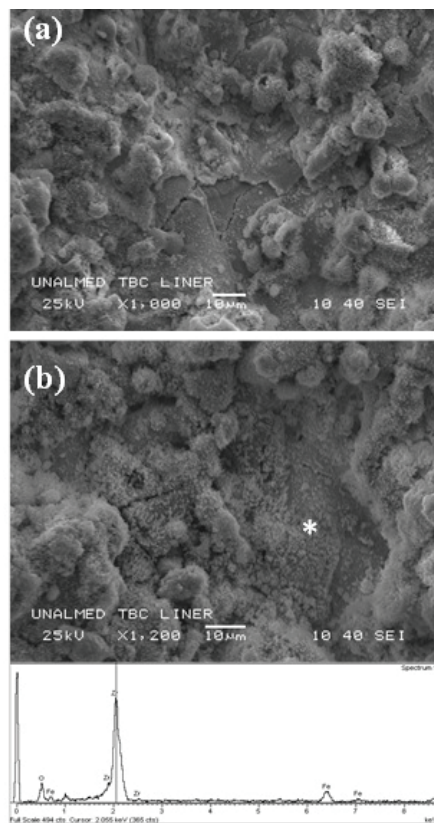
**Figure 14.** Sem micrograph of liner surface with three types of splat cracks

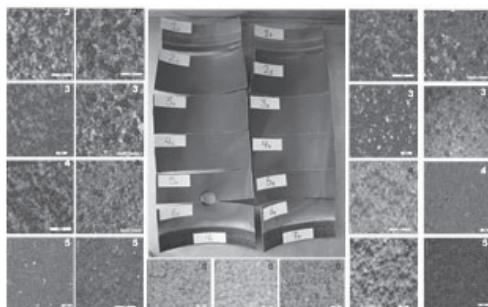
Worn First stage turbine blade, the picture 15 shows different zones and their erosion level, compression side, stagnation point and tip of the blade suffer the major erosion. Visual inspection reveals preferential erosion points due to the combination between thermo-mechanical fatigue or TMF and the combustion gas impact. On the trailing edge both can be appreciated, spallation and gradual erosion of BC y TC. The TC loss in these points leads to the end of the blade lifetime and power losses.

**Figure 15.** Turbine first stage blades. 1, 2 And 4: trailing edge and stagnation point. 3, 7, 8, 9 And 10: leading edge near the tip, compression side. 5 And 6: suction side. 11 And 12: compression side, high temperature surface and 13: base of the blade

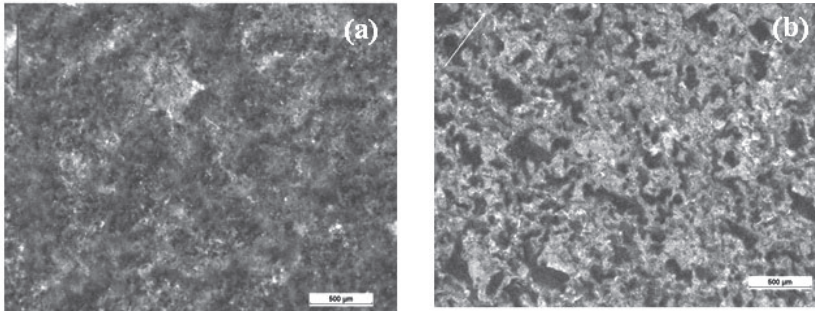
In some areas of the compression side the gradual erosion and TC mass loss take place; although this erosion occurs preferentially, the possible cause is a gas impacting randomly on the blade surface. Figure 15 reveals this phenomenon, the TC is the brown-orange darker surface, this color is due to the high temperature revealer ink and corrosion; the BC shows cream surface and the gray and deeper one is the substrate.

**Figure 16.** Stereo micrographs of compression side with serious but gradual erosion by splat removal.

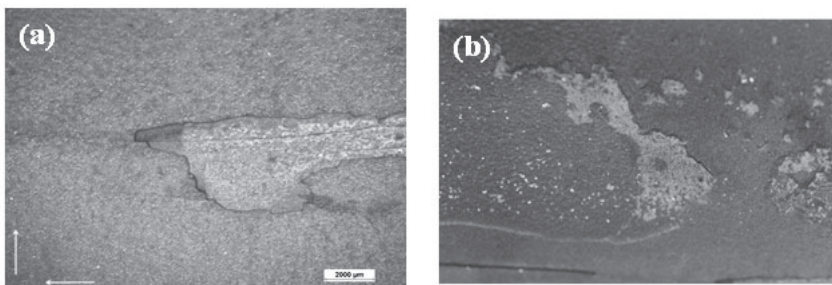
TC degradation by spallation: 1. Delamination or spallation; 2. Exposed perpendicular TC microstructure under gas impact leads to a second spallation. In the Figure 18, the localized spallation occurs in the high temperature zone that allows the crack nucleation in thermal mismatch. The thermal mismatch is intensified by nominal operation conditions as periodic or cyclic operation and their thermal gradients like EPM combined cycle power plant. The spallation follows a linear pattern that continues across the length of the blade, it can be explained for the section changes in the concavity, this means high temperature profiles and abrupt changes in their thermal gradients.

**Figure 17.** (a) stereoscopy of a delaminated tc in compression side (b) photography of tc delaminated by steps in compression side.

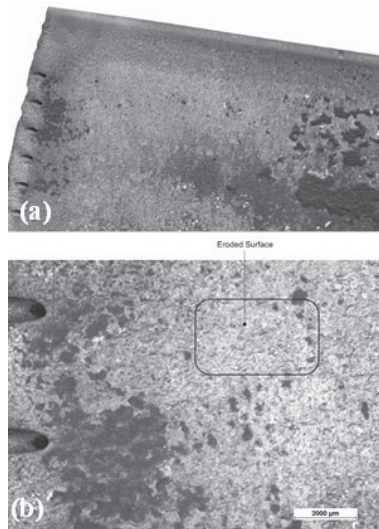
**Figure 18.** Near the tip the erosion is gradual, left. In the center of the blade at the trailing edge the spallation governs the tc removal, right.

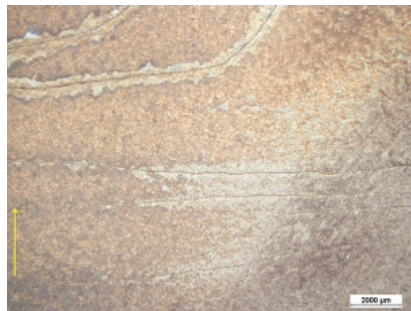
Radial cracks in the center of the compression side developed perpendicular to blade hub and others have an inflection to trailing edge in their propagation. These cracks facilitate material removal; a weak fatigued TC is more susceptible to failure under gas impacts, the TC is delaminated besides the cracks, figure 19. In this case the crack growth appears within erosion and in this condition is difficult to determine which event occurs at first. The roughness was increased possibly by splat removal, Figure 20.

**Figure 19.** Radial cracks into compression side.

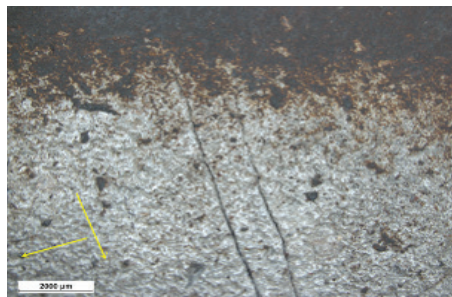
**Figure 20.** Combined transversal cracks and high temperature erosion by splat removal.

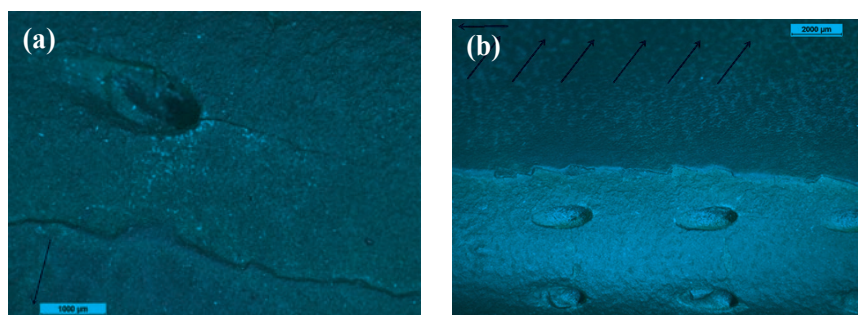
In the trailing edge the combination between spallation and gradual TC erosion make the worn morphology. This zone is characterized for shockwaves impact and high energy rotational cells caused by boundary layer loss. Some qualitative changes in surface roughness are observed in Figure 19, this could generates more erosion and power loss due to rotational cells. Although the erosion patterns reveal gradual mass loss, they are considerable compared with other surface areas in the blade, the mechanisms do not include an abrupt mass loss or marked spallation, the mass loss come from the surface. In some areas the BC appears with some points where substrate is arising.

The aerodynamics holes in the leading edge have cracks possibly caused by thin substrate thickness near the surface Figure 21 (a). These kind of cracks start in the hottest section of the blade, their length can reach the 2 mm. Around the stagnation point the thermal degradation combined with the erosion facilitate the TC delamination and its removal, this can be explained by high thermal gradients generated from the temperature difference between cooled substrate and TC surface, Figure 21 (b).

**Figure 20.** (a) and (b) micrographics of trailing edge with spallation or delamination by tmf and erosion.

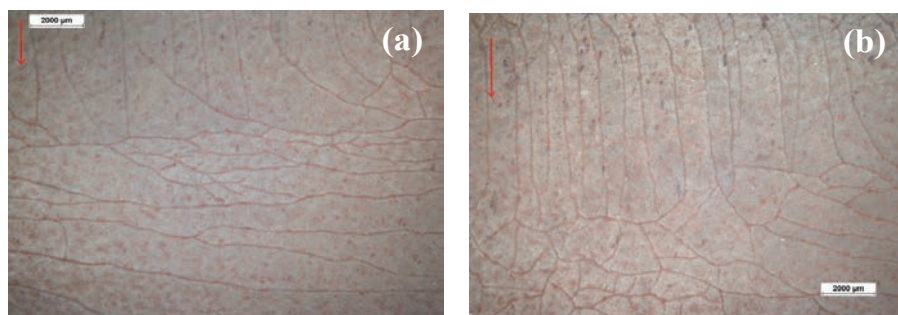
The cracks in the suction side grow transversely near the leading edge and they grow longitudinally near the middle of the surface, intersecting both at the central zone while the cracks in the compression side, especially in the high temperature zone grow longitudinally. At high speed in the turbines (3600 rpm) the centrifugal forces generate axial cracks like those observed in Figure 22.

**Figure 22.** Tc radial and transversal cracks patterns in the middle of the suction side; the arrows indicate the gas flow direction.

According to literature, axial cracks are formed under axial forces at high rotational speed; transversal (radial) cracks are formed due to a temperature gradient between leading edge and trailing edge. The observed cracks were developed in the compression and the suction side of the blade. They could be intersected with lateral and median internal cracks removing the TC and contributing to erosion. The hole's crack in the blade leading edge can be attributed to the TC loss by TMF and the thermal mismatch in a thin substrate layer. The damage can continue affecting the aerodynamic of the blade causing power loss.
