# Revisión, observaciones y consideraciones sobre la erosión a alta temperatura en PS TBC para inspección técnica en turbinas a gas

## High temperature erosion observations, considerations and overview in PS YSZ TBC for power gas turbine technical inspection

Augusto César Barrios<sup>1</sup>, Gabriel Jaime Ovalle<sup>2</sup>, José David Acosta<sup>3</sup>,  
Andrés Felipe Sánchez<sup>4</sup>, David Alejandro Marulanda<sup>5</sup>,  
Óscar Alejandro Arroyave<sup>6</sup>, Freddy Jiménez Navas<sup>7</sup>, Carlos Mario Serna<sup>8</sup>

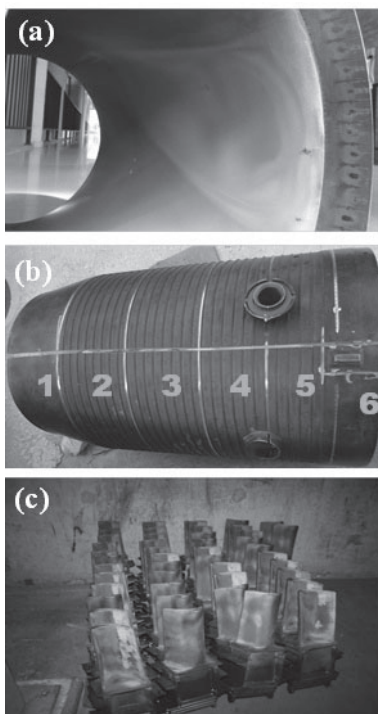
**Figure 5.** (a) And (b) Liner sectioning: the worn surfaces of the liner were identified and classified. (c) Gas turbine blades extracted during maintenance. Courtesy EPM.

In several areas of the liner the rounded particles are found, the EDS results confirm that their composition is mainly YSZ. The other composition amounts correspond to contaminants like Ca and Fe, the foreign objects in the environment and main composition of revealing ink, respectively. It is possible that unmelted YSZ particles were deposited at lower temperatures than formed splats in the plasma spray process. The statistical results on unmelted particles show values between 20 to 264  $\mu\text{m}$  of diameter with a mean of 110  $\mu\text{m}$ .
